**CAPITOL ZONING DISTRICT COMMISSION  
STAFF REPORT  
2/19/14  
TDM / BIM**

**Location:** 1510 S. Arch Street & 615 W. 15<sup>th</sup> Street  
**Applicant:** Cassie Toro for Gaines Street Baptist Church  
**Permit Type:** Certificate of Appropriateness

**Project Description:** This application is for a Certificate of Appropriateness to allow for the removal of the existing structures, parking lots, and other site features in Block 214 of the Original City of Little Rock.

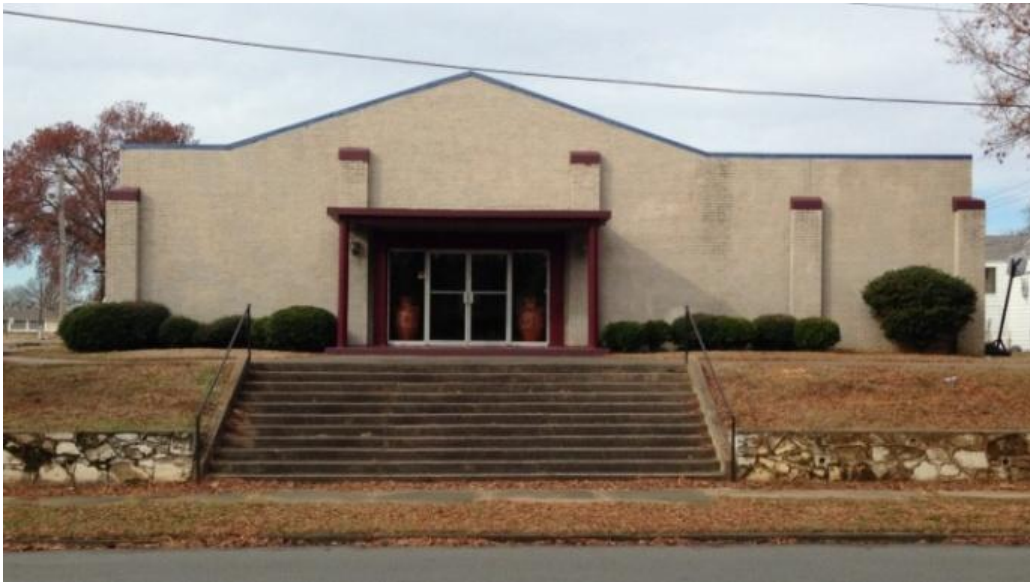
Front façade of 1510 S. Arch

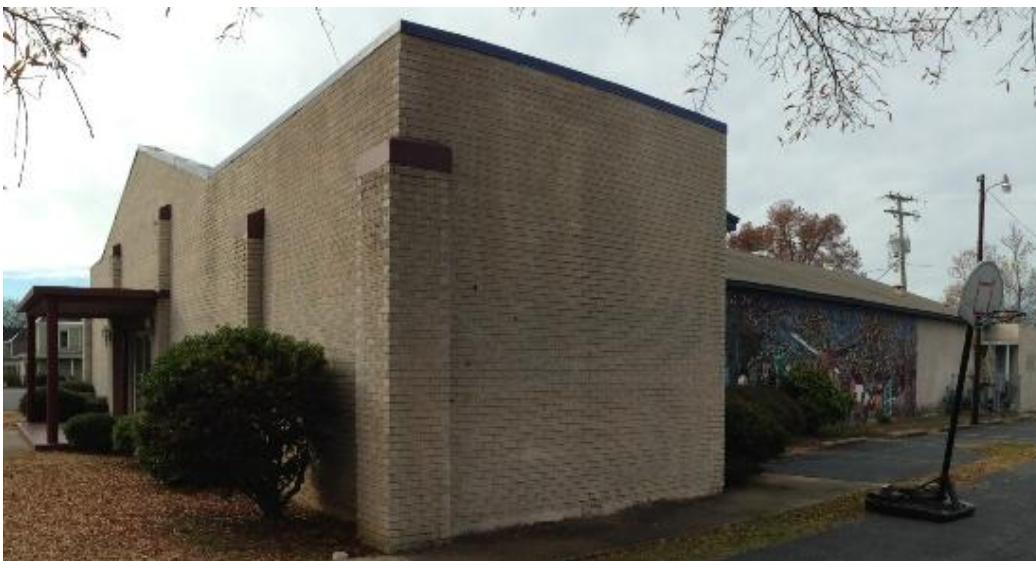
Northeast corner of church building

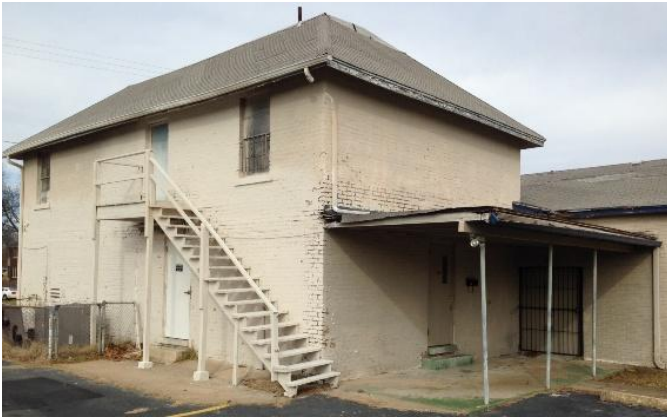
This two-story wing at the southwest corner of the church building was originally the garage apartment of the former house at 1510 S. Arch. It is now the oldest structure on the block.

- 3) The church building, though historic, was not constructed during the District's period of significance;
- 4) The attached two story structure at the southeast corner of the church was built during the District's period of significance, but was substantially altered by the addition of the church building;

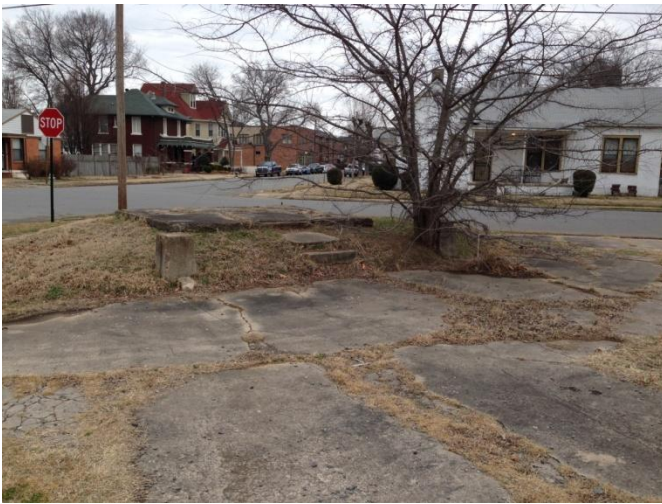
Circular driveway of former store at southeast corner of 15<sup>th</sup> and Gaines

The block proposed for clearance also includes several site features including parking lots, some trees and historic retaining walls, and the circular concrete driveway of a former store at the northwest corner.

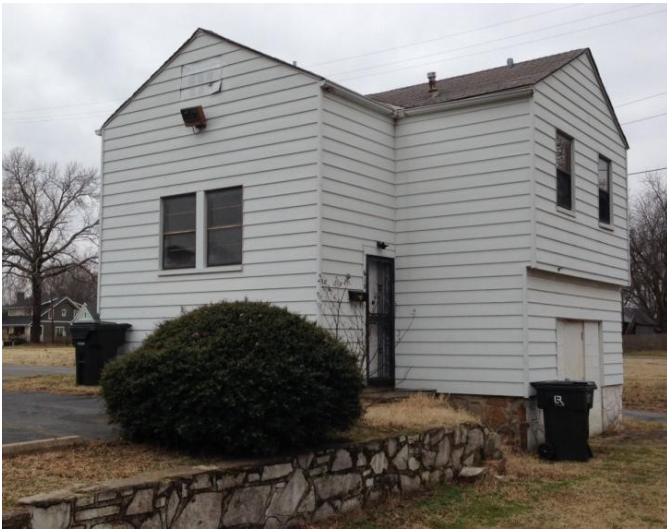
House at 615 W. 15<sup>th</sup> (built as garage apartment of former house at 1500 S. Arch)

The only structure remaining on the block, other than the church at 1510 Arch, is the small house at 615 W. 15<sup>th</sup> Street. This plain traditional structure with was built in the 1940s as a garage apartment for the former Gillespie House at 1500 S. Arch. Also owned by Gaines Street Baptist Church, it has been recently used as church offices and rental residential. It is unknown when the original windows were replaced and artificial siding installed. The structure is located in the Governor's Mansion Historic District, but its status as contributing or non-contributing was never evaluated.

- 5) The house at 615 West 15<sup>th</sup>, though historic, was not built during the District's period of significance;
- 6) The proposed demolitions are wholly inconsistent with all of the applicable review criteria;
